# Laser controlled melting of H12 hot-work tool steel with B<sub>4</sub>C particles at the surface

B.S. Yilbas<sup>a,\*</sup>, F. Patel<sup>a</sup>, C. Karatas<sup>b</sup>

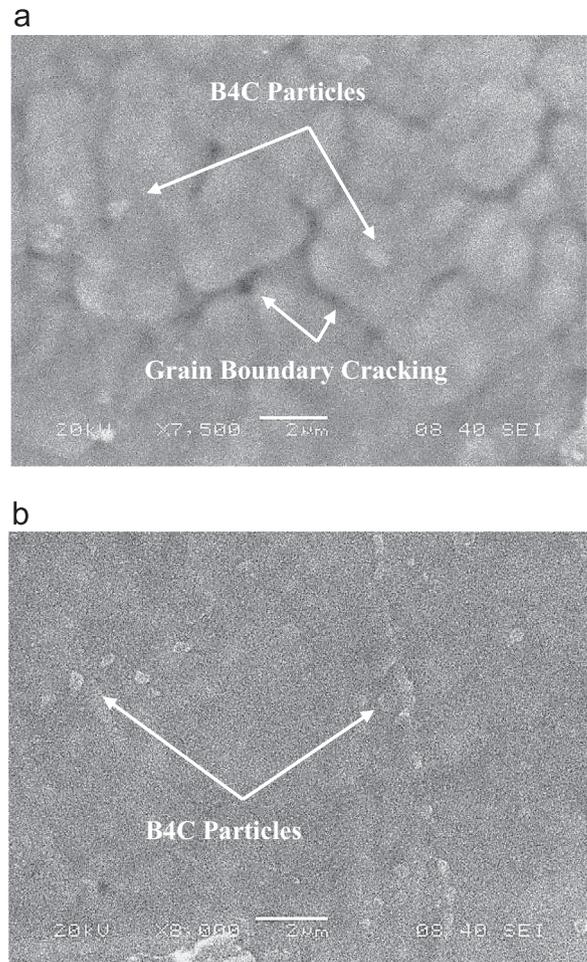
**Fig. 1.** Laser treated surface at two laser output power intensities. (a) Laser treated above 15% laser selected output power and (b) laser treated at the selected output power.

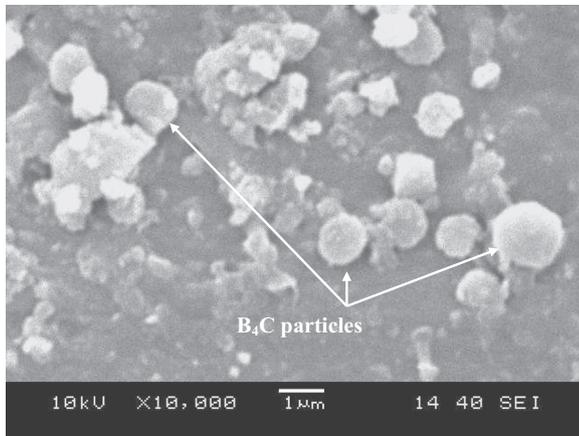
**Fig. 2.** SEM micrographs of B<sub>4</sub>C particles used in the experiments.

painting technique at the workpiece surface to form a layer with almost uniform thickness. The average powder size was 0.5  $\mu\text{m}$ . Fig. 2 shows SEM micrograph of  $\text{B}_4\text{C}$  particles used in the experiments. With the multiple treatments in argon environment at 6 bar pressure in a furnace at temperature ranges 150–400 °C, the phenolic resin film was transformed into a carbon film accommodating 5%  $\text{B}_4\text{C}$  particles at the workpiece surface. It should be noted that almost uniform carbon layer was formed into a uniform film under the high pressure and temperature; in which case, pores formed in the carbon film, due to evaporation of water, was collapsed under the high pressure while resulting in almost uniform thickness carbon film. The pre-prepared workpiece surfaces were scanned by a laser beam according to the parameters given in Table 1.

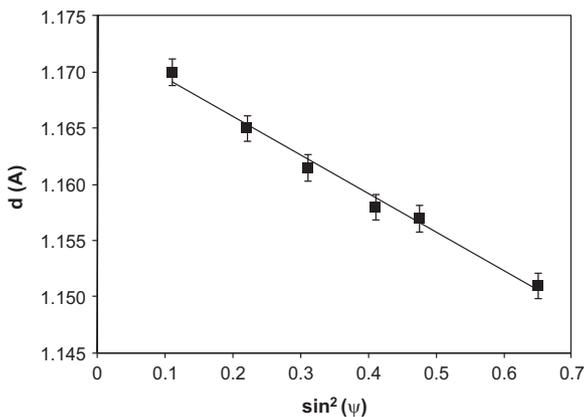
**Fig. 3.** Linear dependence of  $d(211)$  with  $\sin^2(\psi)$ .

where  $E$  is Young's modulus,  $\nu$  is Poisson's ratio,  $\psi$  is the tilt angle, and  $d_n$  are the  $d$  spacings measured at each tilt angle. If there are no shear strains present in the specimen, the  $d$  spacing changes linearly with  $\sin^2 \psi$ . The bcc ferrite steel peak at (211) planes takes place at  $2\theta = 88.3^\circ$  with the inter-planer spacing of 0.11709 nm. The linear dependence of  $d(211)$  results in the slope of  $-3.27 \times 10^{-13}$  m and the intercept of  $1.17 \times 10^{-10}$  m in Fig. 3. The residual stress determined is of the order of  $480 \pm 15$  MPa. XRD measurements are repeated three times and the error related to the measurements is on the order of 3%. In addition, the coefficient of determination corresponding to the linear fit is  $R^2 = 0.99$ .

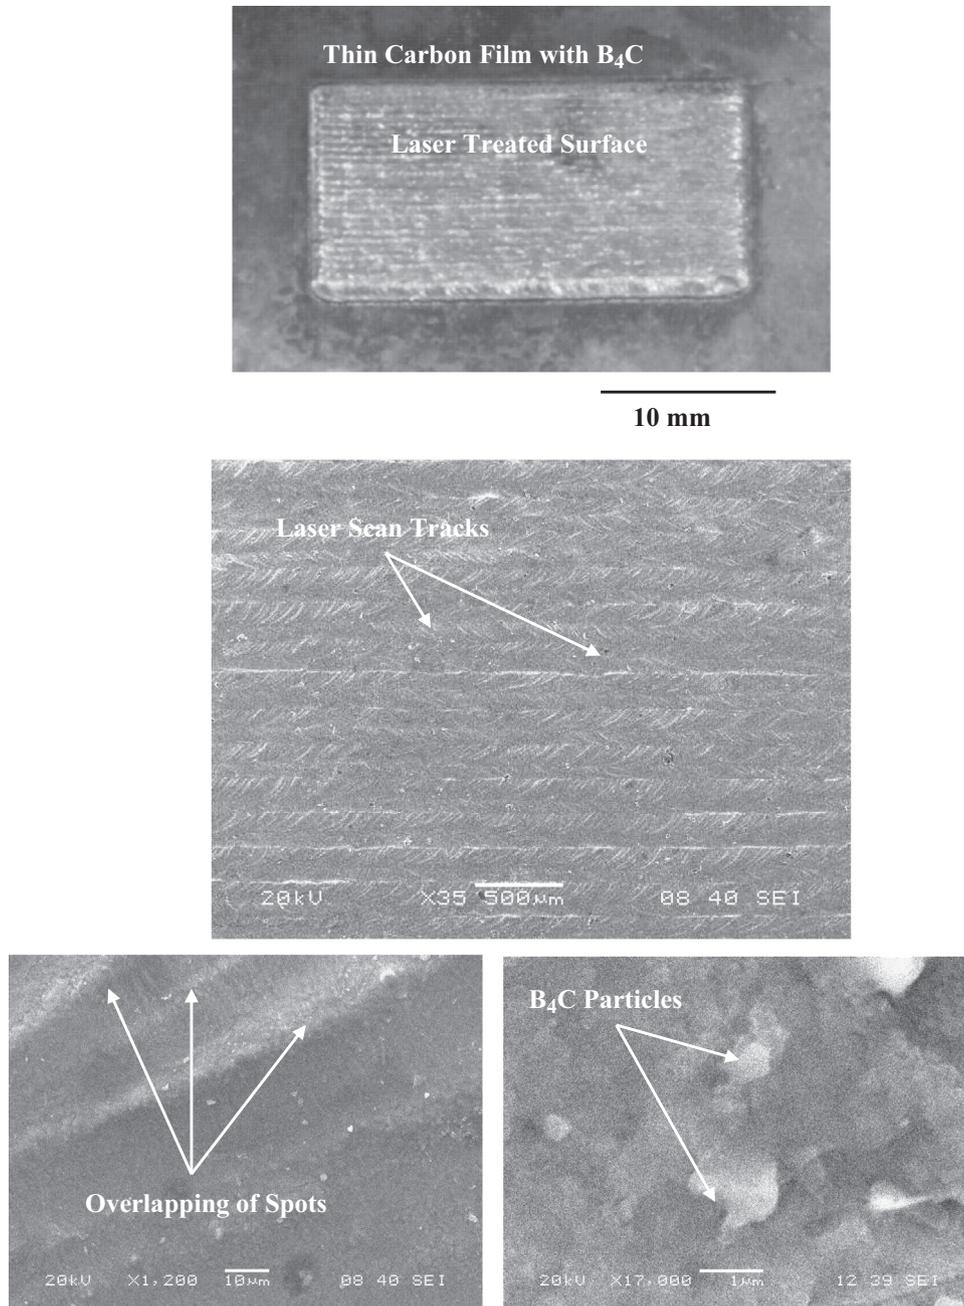
Fig. 4. Optical photograph and SEM micrographs of laser treated surface.

Fig. 4 shows optical photographs and SEM micrographs of laser treated surface. It can be observed that the treated surface is free from large defect sites such as large cracks or crack networks. It should be noted that heat transfer from recently formed laser scanning tracks towards the early form tracks modifies the cooling rates. This, in turn, minimizes the thermally induced crack formation at the surface. Laser scanning tracks are distinguishable at the surface and they consist of overlapped laser spots. The close examination of the spots shows that overlapping ratio of the spots is on the order of 75%. It should be noted that laser heating at the surface took place with consecutive pulses with high repetition rate (1000 Hz). This results in overlapping of the irradiated spots at the workpiece surface. High magnification micrograph shows that partially embedded B<sub>4</sub>C particles are present at the surface. This is associated with high melting temperature of B<sub>4</sub>C. Since the melting at the surface is controlled to avoid evaporation at the surface, surface temperature of the workpiece remains within the neighborhood of the melting temperature of the substrate material. It should be noted that high laser pulse intensity results in excessive heating at the surface; in which case, surface evaporation is resulted and the cavity formation becomes unavoidable at the surface. The cavities produced, due to surface evaporation, increase the surface roughness and adversely affect the uniformity of the treated layer thickness. Since B<sub>4</sub>C particles and the base material have different thermal expansion coefficients, microstresses are formed around B<sub>4</sub>C particles after the completion of solidification. However, the close examination of the surface reveals that no microcrack or crack network is formed in the vicinity of B<sub>4</sub>C particles at the treated surface. This indicates that the micro-stress levels formed at the surface are not high enough to initiate crack formation at the surface. Thermally induced stresses can cause the large crack formation at the surface due to high cooling rates, which covers the large area. However, the mismatch between the thermal expansion coefficients of B<sub>4</sub>C and base alloy results in high strain in the near region of B<sub>4</sub>C particles and the base alloy due to contraction during the solidification process. Therefore, micro-cracks or crack networks are expected to appear when the thermal strain due to this mismatch is high. The presence of crack free regions can be attributed to the self annealing effect of the previously formed laser scanning tracks. In this case, heat transfer from the previously formed tracks to the near region of B<sub>4</sub>C particles suppresses the high solidification rates

and lowers the micro-stress levels at the surface. Moreover, the surface is composed of fine grains indicating the high cooling rates. Although the solidification rate is slowed down due to self annealing effect, the cooling rate is high at the free surface. This is associated with the assisting gas, which enhances the convection cooling at the surface.

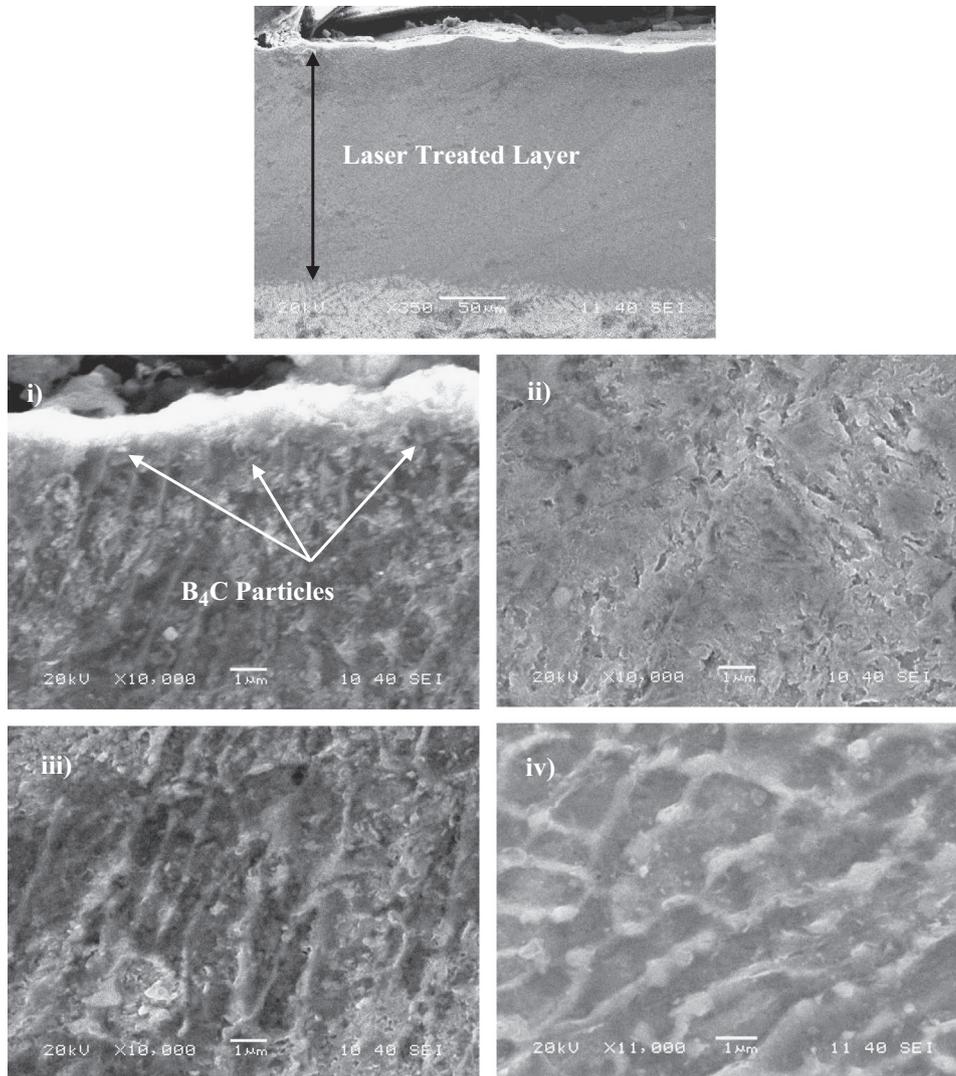
Fig. 5. SEM micrographs of laser treated layer: (i) fine grains and dense structure, (ii) feathery like structure, (iii) fine dendrites and (iv) cellular structure.

Fig. 5 shows the cross-section of the laser treated layer. The treated layer thickness extends almost uniformly 250  $\mu\text{m}$  below the surface. This is attributed to the constant laser scanning speed at the surface. Three regions can be distinguished in the treated layer. In the first region, fine grains and dense layer is formed at the surface vicinity. In addition, randomly scattered  $\text{B}_4\text{C}$  particles are also evident in this region. The formation of fine grains and dense structure is because of the high cooling rates at the surface. Since nitrogen at high pressure is used at the surface, nitride compounds formed in the surface vicinity contributing to the formation of dense layer. This

is because of the volume shrinkage at the surface vicinity leading to dense structure in this region. Moreover, no micro-crack is observed around  $\text{B}_4\text{C}$  particles due to mismatch of thermal expansion coefficient. However, few micro-voids are observed in the vicinity of the dense layer. This is attributed to volume shrinkage at the surface because of density variation. In the second region, which starts from the near vicinity of the dense layer, fine and closely spaced dendrites are formed. Since the cooling rates in this region is less than that at the surface, relative slow cooling rates is responsible for the formation of the closely spaced dendrites. However, the orientation of these dendrites is multi-directional, which indicates the non-uniform cooling in this region. The ferritic-pearlitic microstructure is transformed to a martensite in the dendritic spacing. As the depth below the surface increases further, the size of the dendrite increases and the cellular type structure is formed. This is attributed to relatively slow cooling rates in this region as compared to that

corresponding to the surface vicinity. The feathery like structures, which are formed in the close region of the surface, indicates the presence of nitrogen diffusion in this region. The use of high pressure nitrogen assisting gas is responsible for the formation of feathery like structures in this region. In the third region, grain coarsening is observed because of the slow cooling rates in this region. The demarcation line between the laser treated layer and the base material is visible. This is attributed to heat conduction from the treated layer to the base material, which influences the grain size in this region.

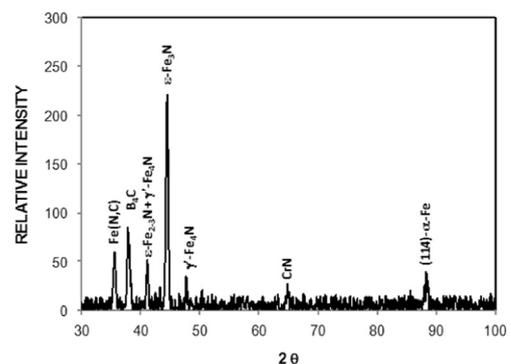
Fig. 6. X-ray diffractogram for laser treated surface.

Fig. 6 shows X-ray diffractogram for the laser treated surface. The nitride peaks are evident from the diffractogram.  $\epsilon$ -Fe<sub>2</sub>N and  $\epsilon$ -Fe<sub>3</sub>N peaks are the nitrogen rich compounds at the surface because of high pressure nitrogen assisting gas. However,  $\gamma$ -Fe<sub>4</sub>N peak corresponds to the precipitates below the surface. This results in feathery like structures below the dense layer, which is also evident from the SEM micrograph. The appearance of Fe<sub>3</sub>(N, C) peaks in the diffractogram is associated with the carbon film formed at the surface prior to the laser treatment process. It should be noted that the position of Fe<sub>3</sub>(N, C) peaks occurs at a less diffraction angle reference to  $\epsilon$ -Fe<sub>3</sub>N phase; consequently, the expansion of hcp lattice of Fe<sub>3</sub>(N, C) phase took place. Moreover, the formation of CrN peaks

in the diffractogram is also observed, which is due to high pressure nitrogen assisting gas. Table 2 gives EDS data obtained at the surface. The change in elemental composition at the surface prior and after the laser treatment process is negligibly small, which indicates no partial evaporation takes place at the surface. Although quantification of light elements such as nitrogen in EDS data involves with error, the presence of nitrogen at the surface is evident. This indicates the formation of nitride compounds at the laser treated surface. Fig. 7 gives line scan of EDS data together with SEM image

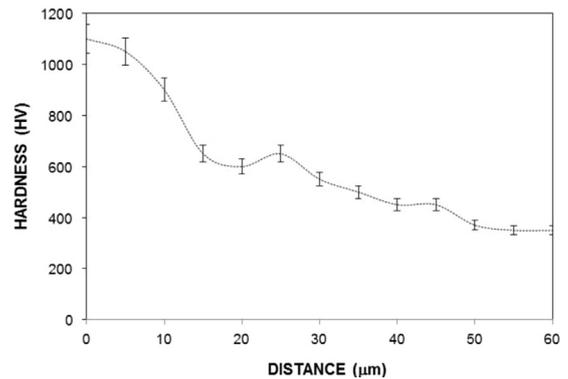
**Fig. 8.** Microhardness variation along the laser treated layer.

where the line scan is carried out. Fig. 7 also contains the close view of the variation of the elemental composition of alloying elements, boron, and nitrogen in the laser treated surface region. It is evident that the depth of nitrogen is about 1.5 μm and boron is about 2.45 μm. Nitrogen reduces sharply in the surface region while boron remains almost constant. Consequently, the depth of nitrogen diffusion is limited with the surface region and mixing of B<sub>4</sub>C particles with the base alloy takes place in the shallow depth of the laser treated layer. Fig. 8 shows microhardness depth distribution across the laser treated layer. Microhardness attains the maximum value in the surface region where B<sub>4</sub>C particles are concentrated. As the depth below the surface increases, microhardness reduces first sharply and, then, the decay becomes gradual. Table 3 gives the

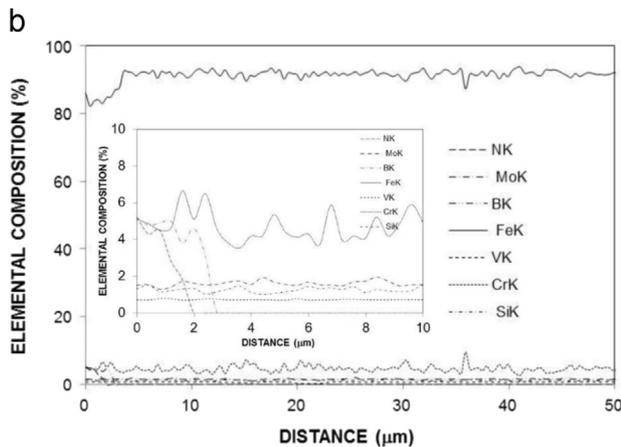
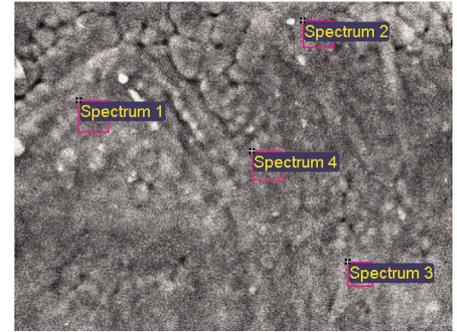
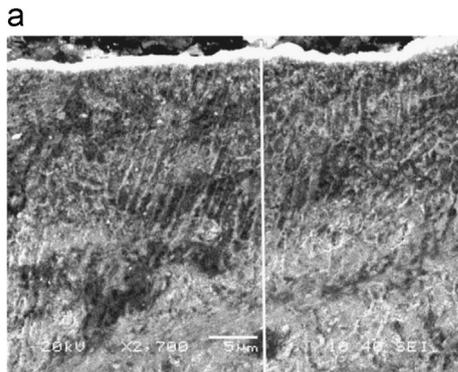
**Fig. 7.** EDS line scan across the cross-section of the laser treated layer. Small figure represents the elemental composition close to the laser treated surface (iron data is excluded to observe nitrogen and boron data): (a) SEM micrograph and (b) elemental distribution.

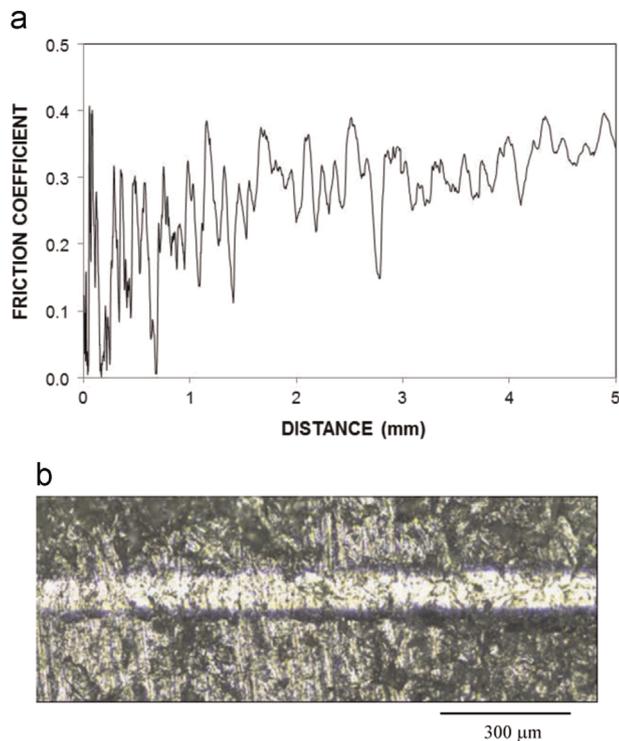
**Fig. 9.** Friction coefficient and scratch mark for laser treated layer. (a) Friction coefficient along the laser treated surface and (b) scratch mark resulted after the tests.

Fig. 9 shows friction coefficient of the laser treated surfaces (Fig. 9a) and the scar marks (Fig. 9b) resulted during the scratch tests. Since the friction coefficient of the as received tool steel is 0.60 ± 0.045 [21], laser treatment lowers the friction coefficient at the surface. This is associated with reduced surface roughness and enhancement of surface microhardness after the laser treatment process. The close examination of the scratch images shows that the scar size is almost uniform and no crack around the scar mark

is observed. This indicates that the surface fracture toughness reduction due to surface hardness enhancement is not significant.
